Metallurgical Examination of an AMTEC Power Unit

Abstract. Two AMTEC power units fabricated by Advanced Modular Power Systems, Inc. using a cold end condenser manufactured by Creare, Inc. which operated for 342 hours and 575 hours were dissected and examined. The maximum output power for both units varied from approximately 68 to 25 mW and 2.6 to 1.8 watts for the respective units during their operational life prior to shutdown. The corresponding BASE tube and condenser temperatures were in the range of 730 C and 390 C for one unit and 705 C and 270 C for the other. The power units were constructed with a stainless steel housing and stainless steel sheathed molybdenum wick. Analysis showed that the internal sodium was primarily distributed near the condenser end of the power unit extending out to a distance of 2.5 cm. No significant amount of sodium was observed in the BASE tubes or plenum. A similar sodium distribution was observed in the second AMTEC cell with a Creare condenser which operated for 575 hours. The wick was sliced into 2 to 3 mm sections and analyzed using a SEM and X-ray fluorescence to determine its sodium distribution. The sodium distribution along the wick from

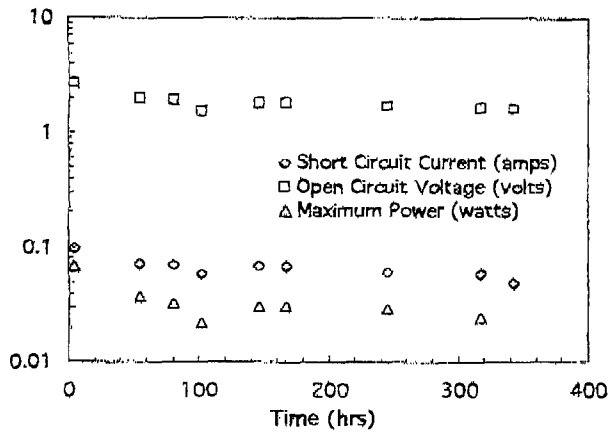
FIGURE 2a. Creare 1 electrical performance.

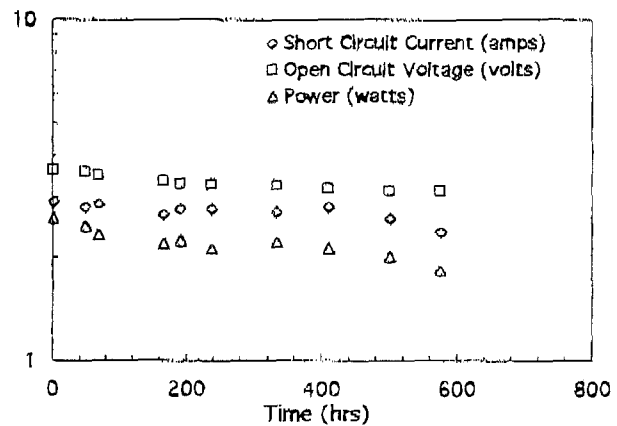
FIGURE 2b. Creare 2 electrical performance.

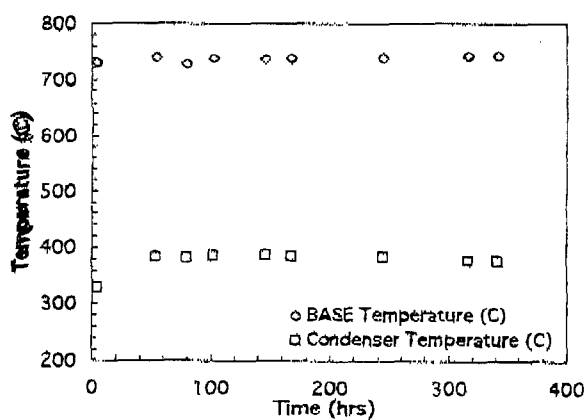
FIGURE 3a. Creare 1 temperatures.

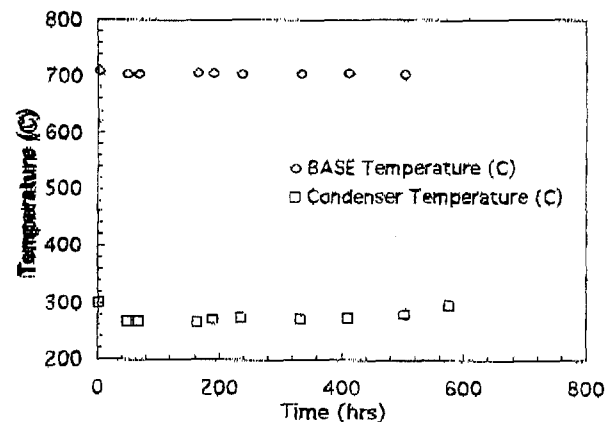
FIGURE 3b. Creare 2 temperatures.

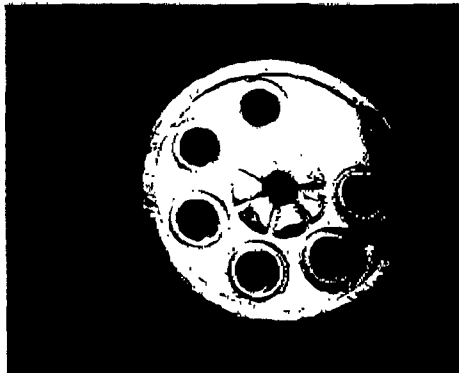
FIGURE 5a. Dissected plenum view.

the Creare 1 power unit. The glistening coating observed on the interior surfaces is due to the high purity low vapor pressure oil used as a cutting lubricant. Figure 5a shows the rear of the BASE tubes after the hot side plenum that contains the sodium vapor under normal operation was removed. The central orifice is the exit path for the expanding sodium vapor from the evaporator. The six peripheral openings lead into the individual series connected BASE tube cells. Under visual observation no coating was apparent on any of the surfaces within the plenum. Several small sodium nodules under 1 mm in diameter were found on the interior surface of one of the tubes near the top inside and in the area of the evaporator. No sodium accumulation was observed in the transition tubes from the plenum to the inside of the BASE tube cells. A thin sodium coating was apparent on the interior electrode grid and upper (i.e. cooler) end of the BASE tubes. The internal sodium was observed pooled near the cooler condenser end of the power unit and extending up approximately 3.2 cm on the exterior surface of the wick which is the central tube in Figure 5b (e.g. the offset tube is the main cathode electrode). Sodium on the interior walls extended about 0.3 cm past the 2nd thick strengthening side wall band (near the left side of Figure 5b). Visual observation in contrast showed no apparent sodium on the exterior surfaces of the BASE tube electrodes (i.e. cathodes) or on any of the internal surfaces near the hotter regions of the power unit (e.g. in the right portion of Figure 5b). During the examination of the interior of the BASE tubes from the plenum end there was an indication that several were broken. Combined electrical resistance measurements across each of the individual cells and along the string of cells implied one or more breaks along the cell string. External examination showed that two adjacent tubes were detached at the point where the BASE tube was braised sealed to the slightly larger diameter alumina insulator that can be seen near the right edge of Figure 5b. A similar examination conducted on Creare 2 discovered two breaks at the BASE tube braise seal at the opposite end of the cell string. The braising surface of one of the broken tubes can

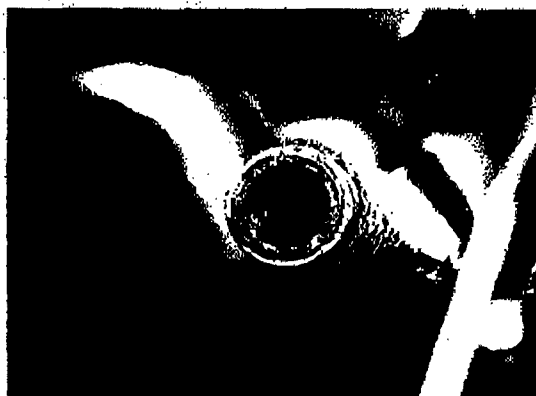
be observed in Figure 6. The relatively smooth surface appears to indicate that the detachment was due to a failure of the braise seal as opposed to a break in the BASE tube.

FIGURE 6. View of severed BASE tube braise seal surface.

The possible cause of the poor operation and failure of these AMTEC power units can be attributed in part to the failure of the braise seal. However sodium transport in the wick could also prove problematic. The wick is Creare 1 was dissected to observe the sodium distribution within its structure. The wick was cut into 15 portions of approximately 2 to 3 mm using a diamond saw. Each wick piece was slowly cut and allowed to break in a slightly irregular manner to minimize smearing of sodium across the cross sectional surface. The unpolished surfaces of each cut wick section was photographed using a scanning electron microscope (SEM) and at the same time subjected to elemental analysis using X-ray florescence. Figures 7 through 9 show the secondary electron SEM photos and back scattered electron SEM photos of the wick cross-section along side the X-ray florescence map of the sodium distribution. The secondary electron photo provides a good image of the surface topography while the back scattered electron image contrasts the regions of heavier atomic mass elements from those of the lighter elements. The lighter regions of the back scattered images reflect the iron dominated regions of the stainless steel wick sheath while the darker area in the middle region of the wick cross section depict areas where sodium is present. The back scattered images area reflecting the sodium presence can be contrasted with the sodium distribution mapped in the 3rd photo in each series which is the x-ray florescence image. The darker areas in each x-ray image are due to electron shadowing and do not reflect a lack of sodium. Figure 7a-c shows the cross sectional surface at a point 3 mm from the point where the wick was inserted into the cold side condenser (i.e. 50 mm from the start of the evaporator as can be seen in Figure 5b). In contrast, Figure 8a-c shows the cross section at the middle of the wick or at a point 21 mm from the condenser (i.e. 32 mm from the start of the evaporator). Finally Figure 9a-c shows the cross section at 50 mm from the condenser and 3 mm from the evaporator. In all three cases the sodium distribution appears uniform across the surface. The uniformity however does not necessarily reflect the efficiency of sodium transport through the wick, only that sodium at some point during the operation has coated the molybdenum wick throughout.

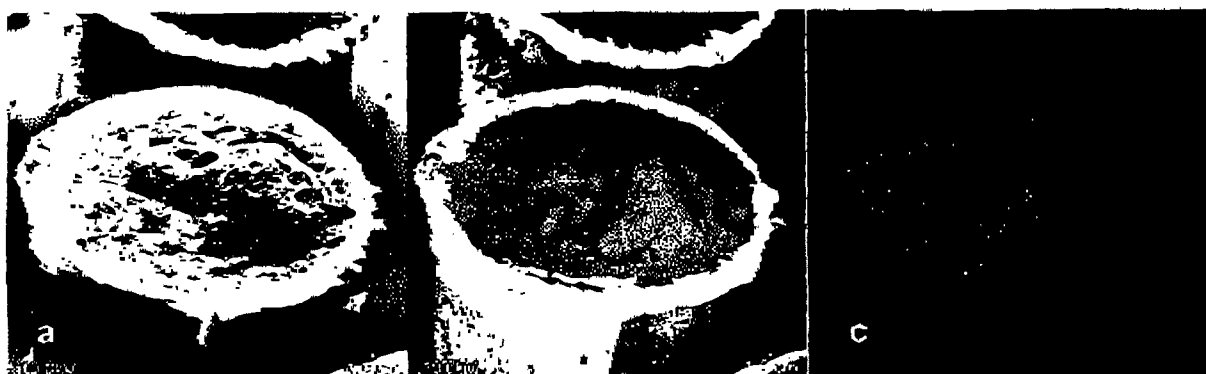
FIGURE 8. . Creare 1 wick cross sectional midway from condenser; (a) secondary electron SEM photo, (b) back scattered electron SEM photo, (c) X-ray florescence map of sodium distribution.
